**Technical Appendix 8.5: Peat Depth Survey Results**

- 1.1.1 Ramboll was commissioned by the Applicant to undertake peat depth and coring survey to aid the design process and to inform an assessment of the nature and condition of the peatland on the Site.

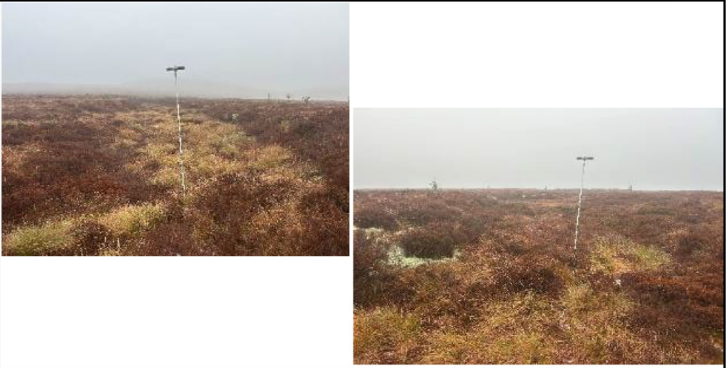
| ID | Grid Reference | Description | Photos | |
|---|---|---|---|--|
| R1 | NS 90538 17726 | Revegetated erosion gulley | | |

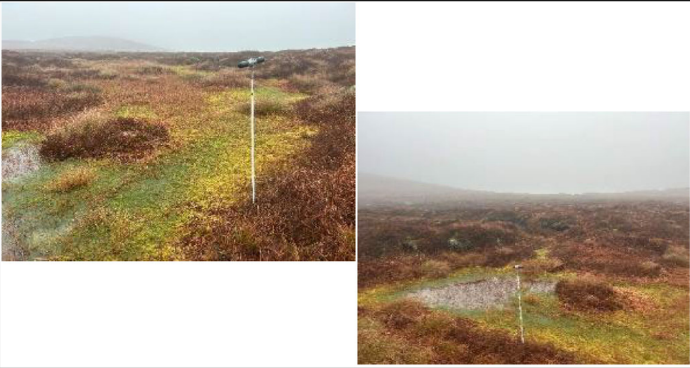
| ID | Grid Reference | Description | Photos | |
|---|---|---|---|--|
| R3 | NS 90473 17796 | Sphagnum pool / peat erosion feature | | |

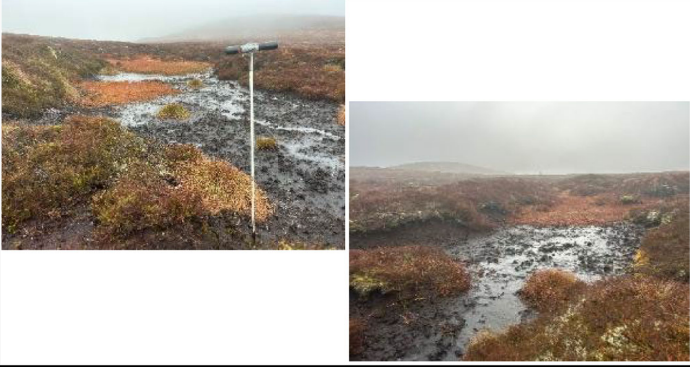
| ID | Grid Reference | Description | Photos | |
|---|---|---|---|--|
| R4 | NS 90470 17825 | Peat erosion feature | | |

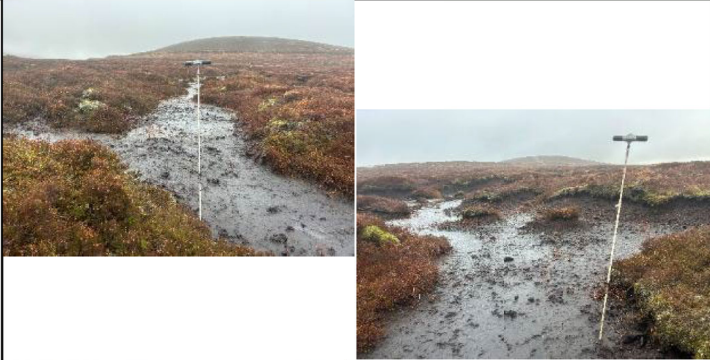
| ID | Grid Reference | Description | Photos | |
|---|---|---|---|--|
| R5 | NS 904609 17846 | Peat erosion feature | | |

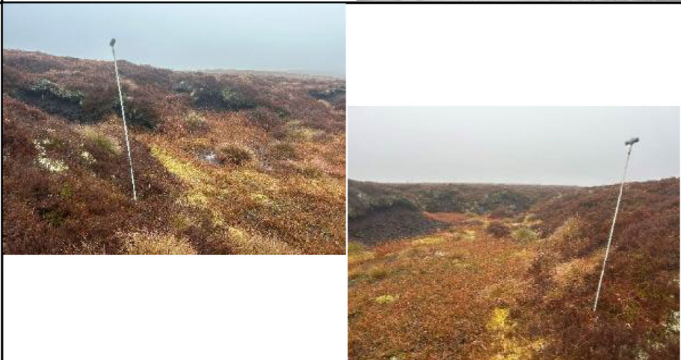
| ID | Grid Reference | Description | Photos | |
|---|---|---|---|--|
| R6 | NS 90432 17884 | Erosion gully | | |

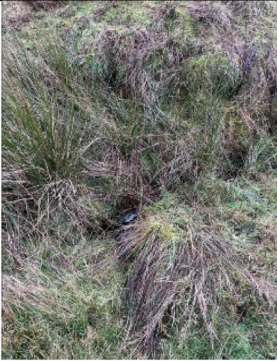
| ID | Grid Reference | Description | Photos | |
|---|---|---|---|--|
| R8 | NS 87922 19070 | Watercourse valley 2 m x 1 m / small watercourse, width 0.2 m x depth 0.1 m, flows to the northeast | | |

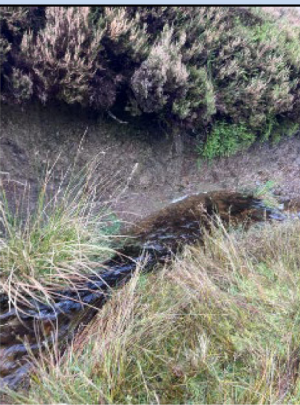
| ID | Grid Reference | Description | Photos | |
|---|---|---|---|--|
| R9 | NS 87296 17138 | Small watercourse, width 0.3 m x depth 0.1 m, flows to the southwest | | |

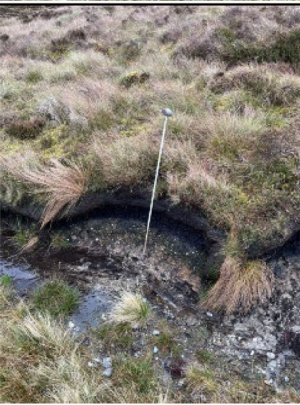
| ID | Grid Reference | Description | Photos | |
|---|---|---|---|--|
| R10 | NS 87635 17012 | Small watercourse, width 0.5 m x depth 0.1 m, flows to the south | | |

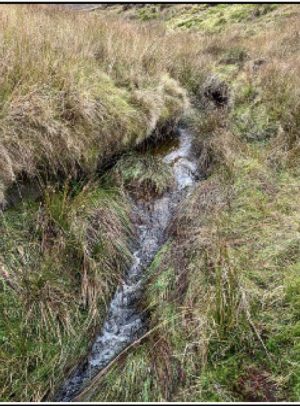
| ID | Grid Reference | Description | Photos | |
|---|---|---|---|--|
| R11 | NS 87361 16939 | Peat erosion feature / small watercourse, width 0.3 m x depth 0.2 m, flows to the north | | |

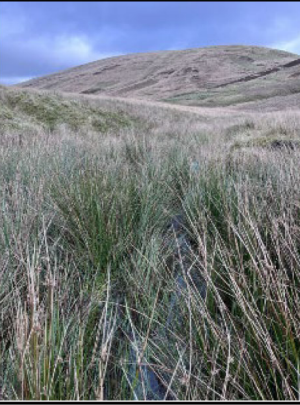
| ID | Grid Reference | Description | Photos | |
|---|---|---|---|--|
| R12 | NS 87304 16807 | Small watercourse, width 0.3 m x depth 0.2 m, flows to the northwest | | |

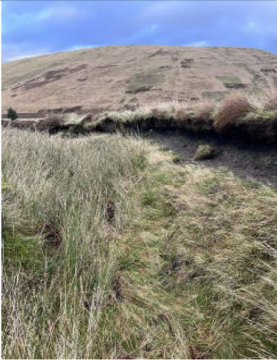
| ID | Grid Reference | Description | Photos | |
|---|---|---|---|--|
| R13 | NS 87193 16811 | Peat erosion feature / small watercourse, width 0.3 m x depth 0.1 m, flows to the northeast | | |

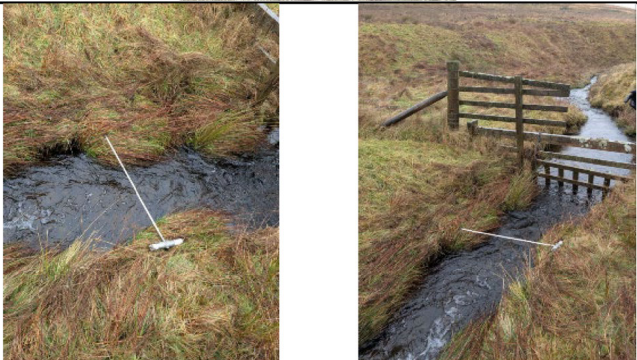
| ID | Grid Reference | Description | Photos | |
|---|---|---|---|--|
| R14 | NS 87089 19161 | Watercourse valley / watercourse, width 0.8 m x depth 0.3 m, flows to the northwest | | |

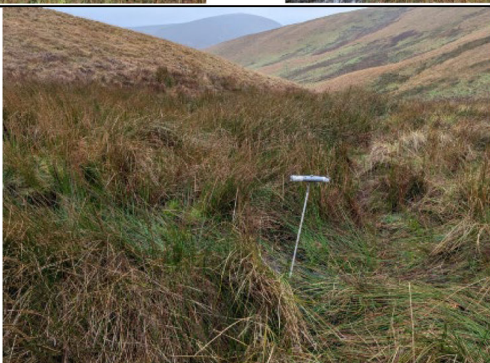
| ID | Grid Reference | Description | Photos | |
|---|---|---|---|--|
| R15 | NS 88425 19213 | Drain, width 0.4 m x depth 0.4 m | | |

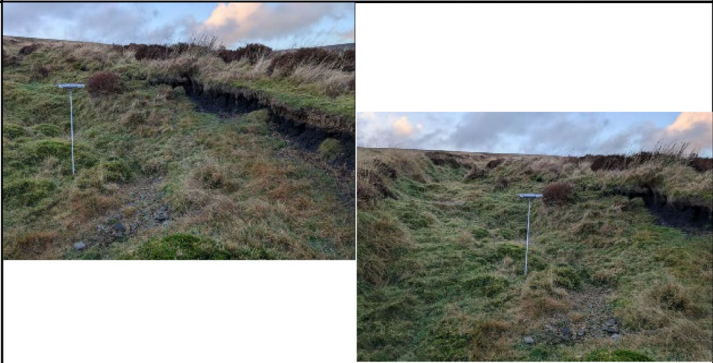
| ID | Grid Reference | Description | Photos | |
|---|---|---|---|--|
| R16 | NS 91221 17287 | Erosion gulley / exposed substrate | | |

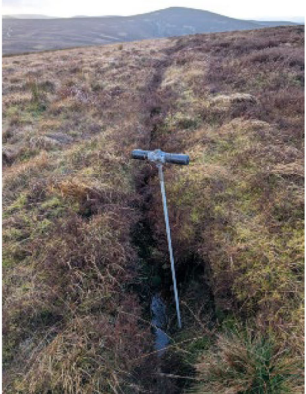
| ID | Grid Reference | Description | Photos | |
|---|---|---|---|--|
| R17 | NS 90552 17425 | Drain, width 0.45 m x depth 0.35 m | | |

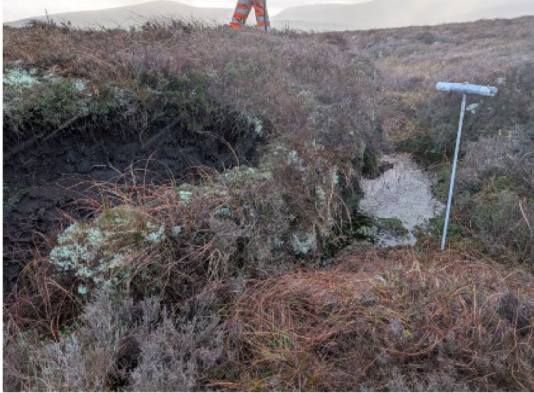
| ID | Grid Reference | Description | Photos | |
|---|---|---|---|--|
| R18 | NS 91722 17847 | Peat erosion feature, width 2 m x depth 1.2 m | | |

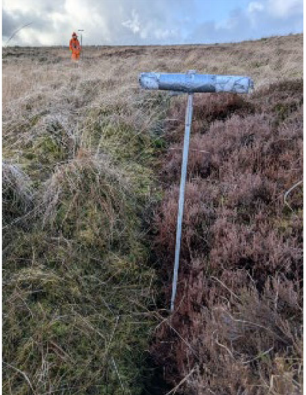
| ID | Grid Reference | Description | Photos | |
|---|---|---|---|--|
| R19 | NS 92383 17859 | Drain, width 0.25 m x depth 0.35 m | | |

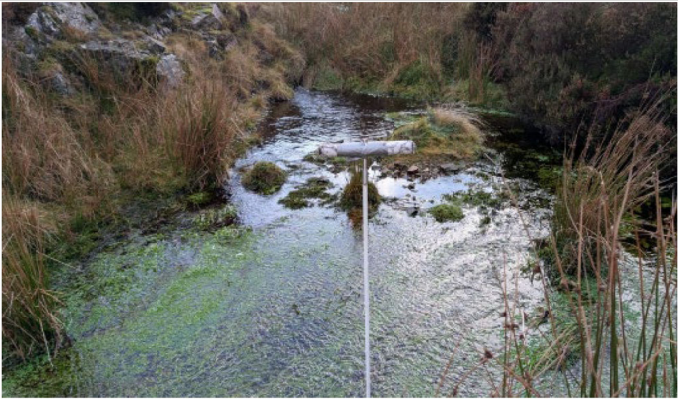
| ID | Grid Reference | Description | Photos | |
|---|---|---|---|--|
| R20 | NS 92577 18832 | Watercourse, width 4.5 m x depth 0.25 m, flows to the north | | |

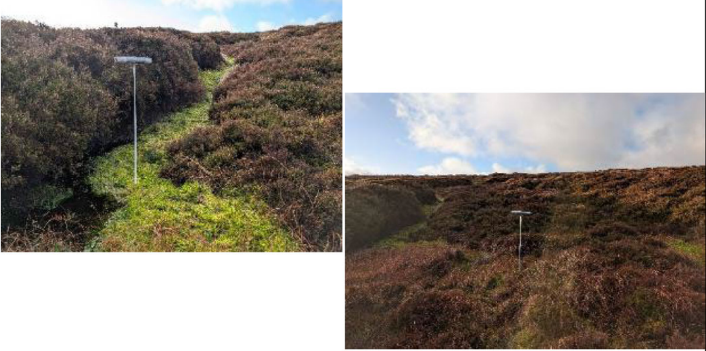
| ID | Grid Reference | Description | Photos | |
|---|---|---|---|--|
| R21 | NS 90356 18990 | Revegetated erosion gulley, width 10 m x depth 1.5 m | | |

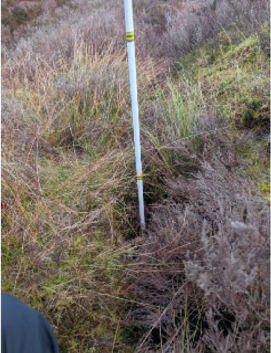
| ID | Grid Reference | Description | Photos | |
|---|---|---|---|--|
| R22 | NS 92361 18545 | Drain, width 0.3 m x depth 0.4 m | | |

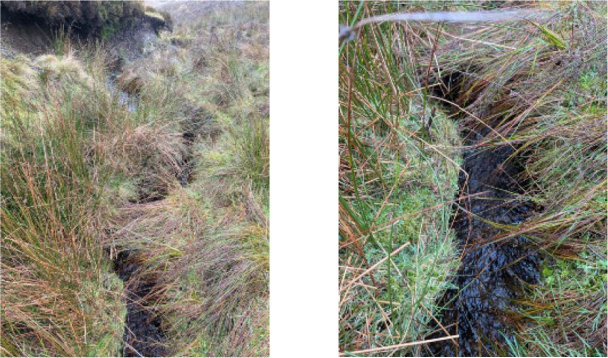
| ID | Grid Reference | Description | Photos | |
|---|---|---|---|--|
| R23 | NS 87969 17020 | Small watercourse, width 0.5 m x depth 0.4 m, flows to southwest | | |

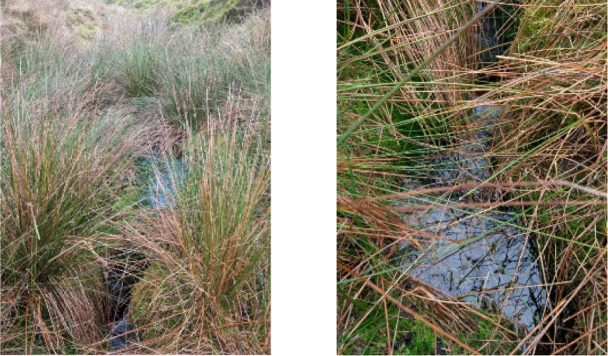
| ID | Grid Reference | Description | Photos | |
|---|---|---|---|--|
| R24 | NS 87382 17203 | Small watercourse, width 0.45 m x depth 0.2 m, flows to the southwest | | |

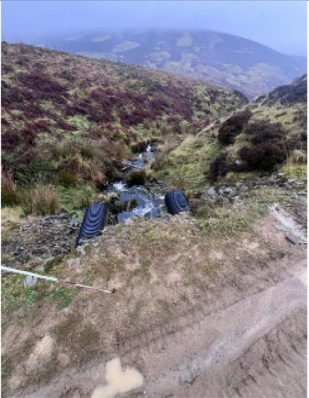
| ID | Grid Reference | Description | Photos | |
|---|---|---|---|--|
| R25 | NS 92570 18849 | Track / watercourse, width 1 m x depth 0.3 m, fows to the northwest | | |

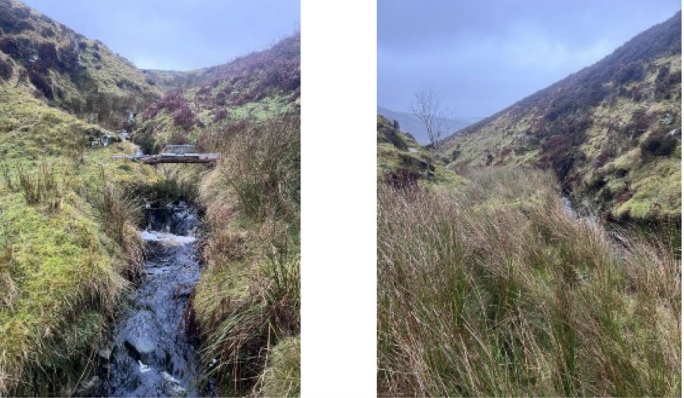
| ID | Grid Reference | Description | Photos | |
|---|---|---|---|--|
| R26 | NS 92551 18883 | Watercourse valley / watercourse, width 1 m x depth 0.3 m, flows to the northwest | | |

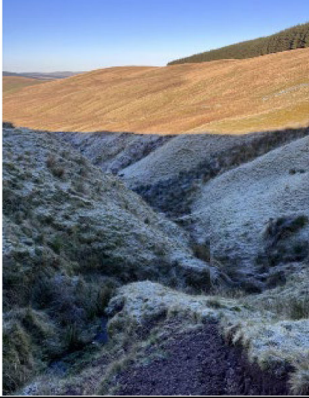
| ID | Grid Reference | Description | Photos | |
|---|---|---|---|--|
| R27 | NS 87922 19070 | Watercourse valley / small watercourse, width 0.4 m x depth 0.15 m, flows to the northwest | | |

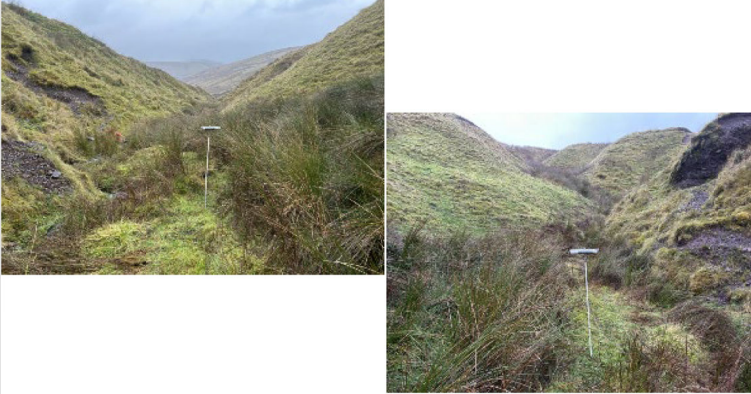
| ID | Grid Reference | Description | Photos | |
|---|---|---|---|--|
| R28 | NS 87902 19089 | Watercourse valley / small watercourse, width 0.3 m x depth 0.1 m, flows to the northwest | | |

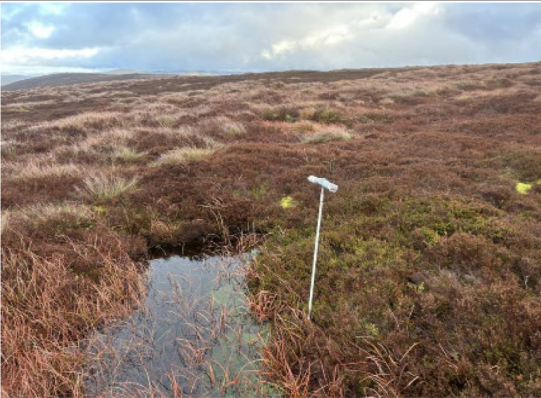
| ID | Grid Reference | Description | Photos |
|---|---|---|---|
| R25 | NS 91291 19019 | Sphagnum pool | |

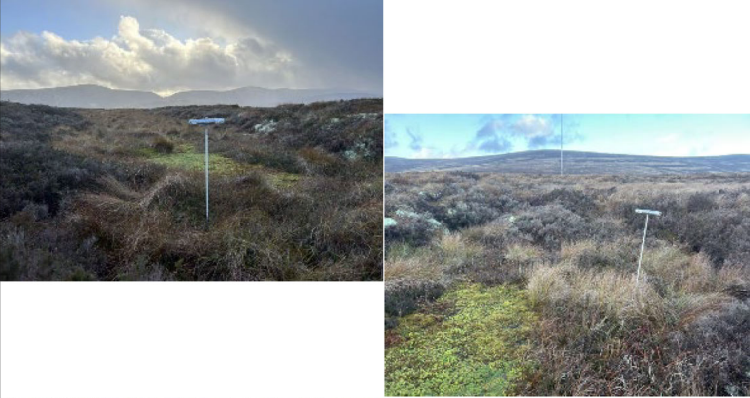
| ID | Grid Reference | Description | Photos |
|---|---|---|---|
| R26 | NS 91832 17842 | Peat erosion feature / sphagnum pool | |

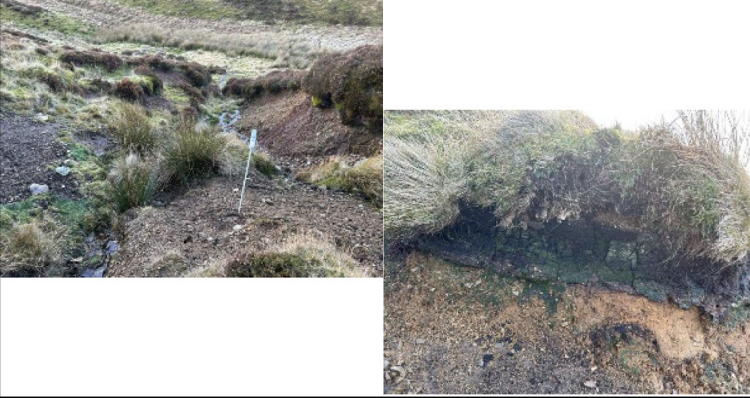
| ID | Grid Reference | Description | Photos |
|---|---|---|---|
| R27 | NS 92441 18132 | Erosion gully, width 5 m x depth 1.5 m | |

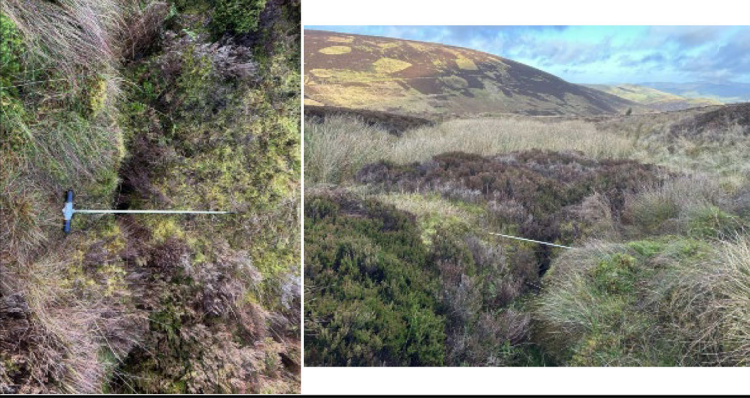
| ID | Grid Reference | Description | Photos |
|---|---|---|---|
| R28 | NS 92445 18596 | Small watercourse, width 0.3 m x depth 0.2 m, flows to the southwest | |
