Figure Title		
Factor of Safety		
Project Name		
Watchman Energy Park		
Project No./Filey ID		
1620016964 / REH2024N01805		
Date	Figure No.	Revision
February 2026	8.6.6	1.0
Prepared By	Scale	
RD	1:28,000 @A3	
Client		
Watchman Energy Park Ltd

Project Name
Watchman Energy Park

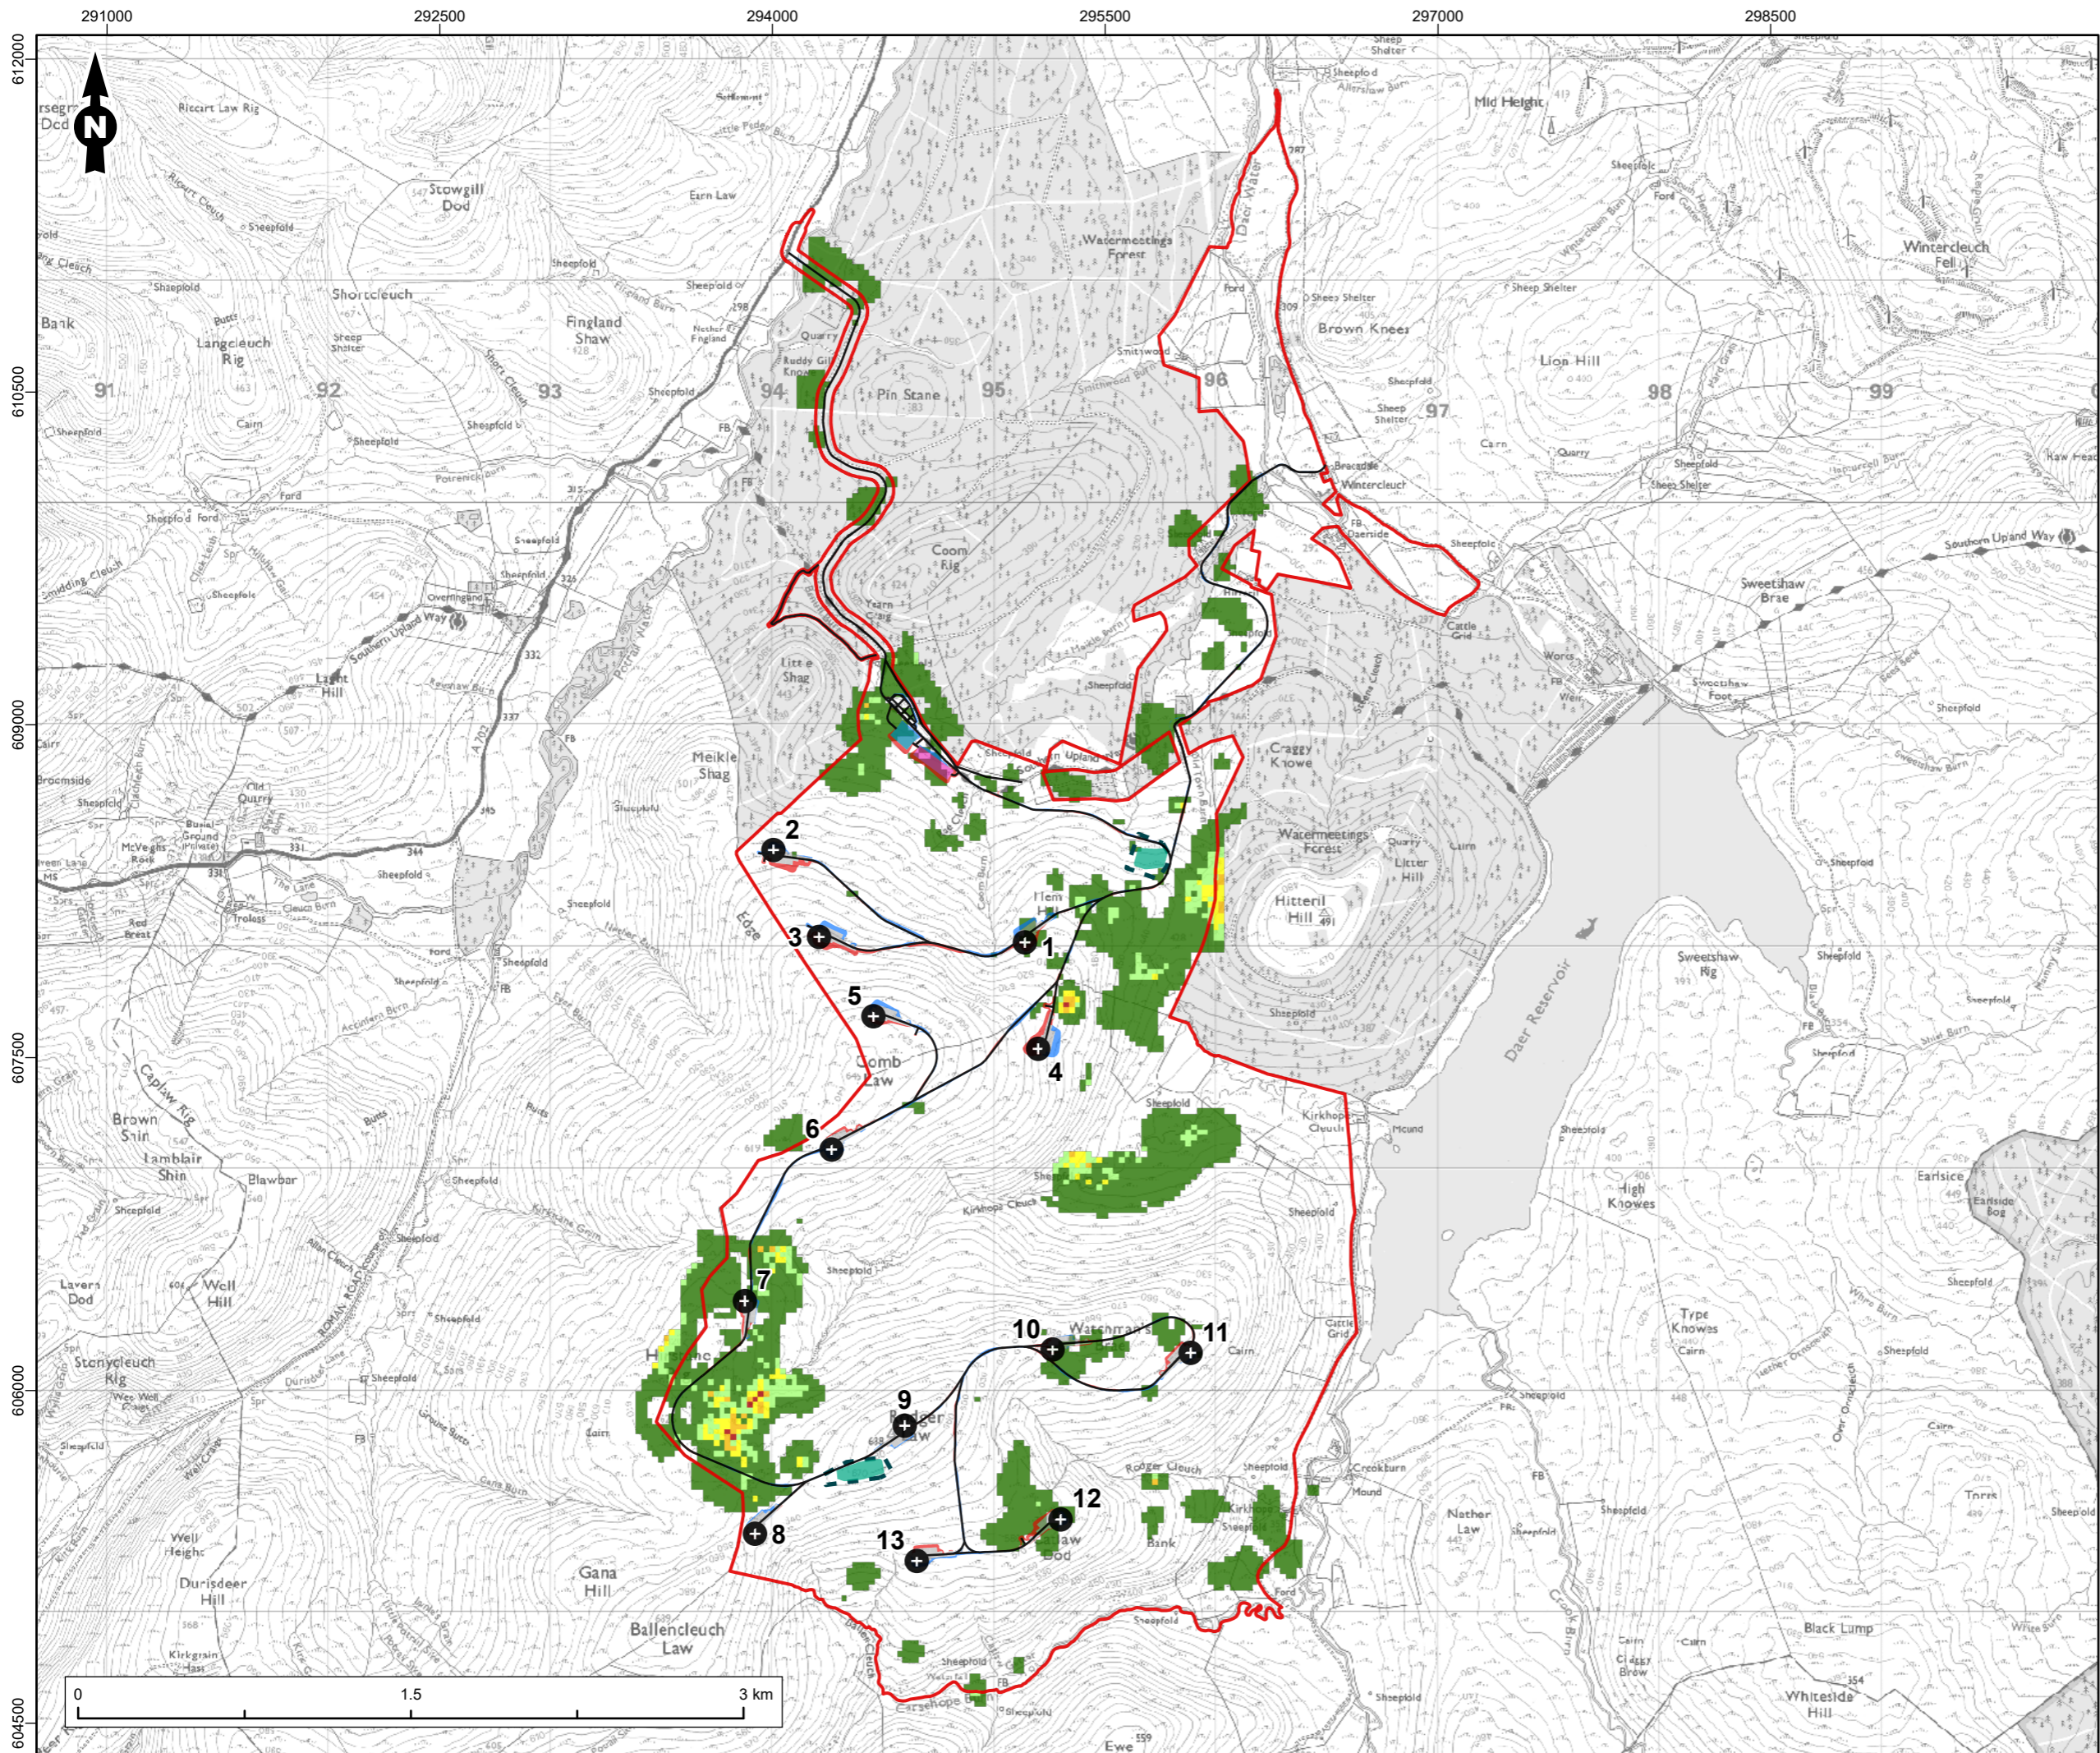
Factor of Safety

- <1.0 (Unstable)
- 1.0 - 1.4 (Marginally Unstable)
- 1.4 - 2.0 (Stable)
- 2.0 - 3.0 (Stable)
- >3.0 (Stable)
